**RAILROAD ACCIDENT INVESTIGATION**

**Report No 3831**

LOUISIANA AND ARKANSAS RAILWAY COMPANY

ALEXANDRIA, LA

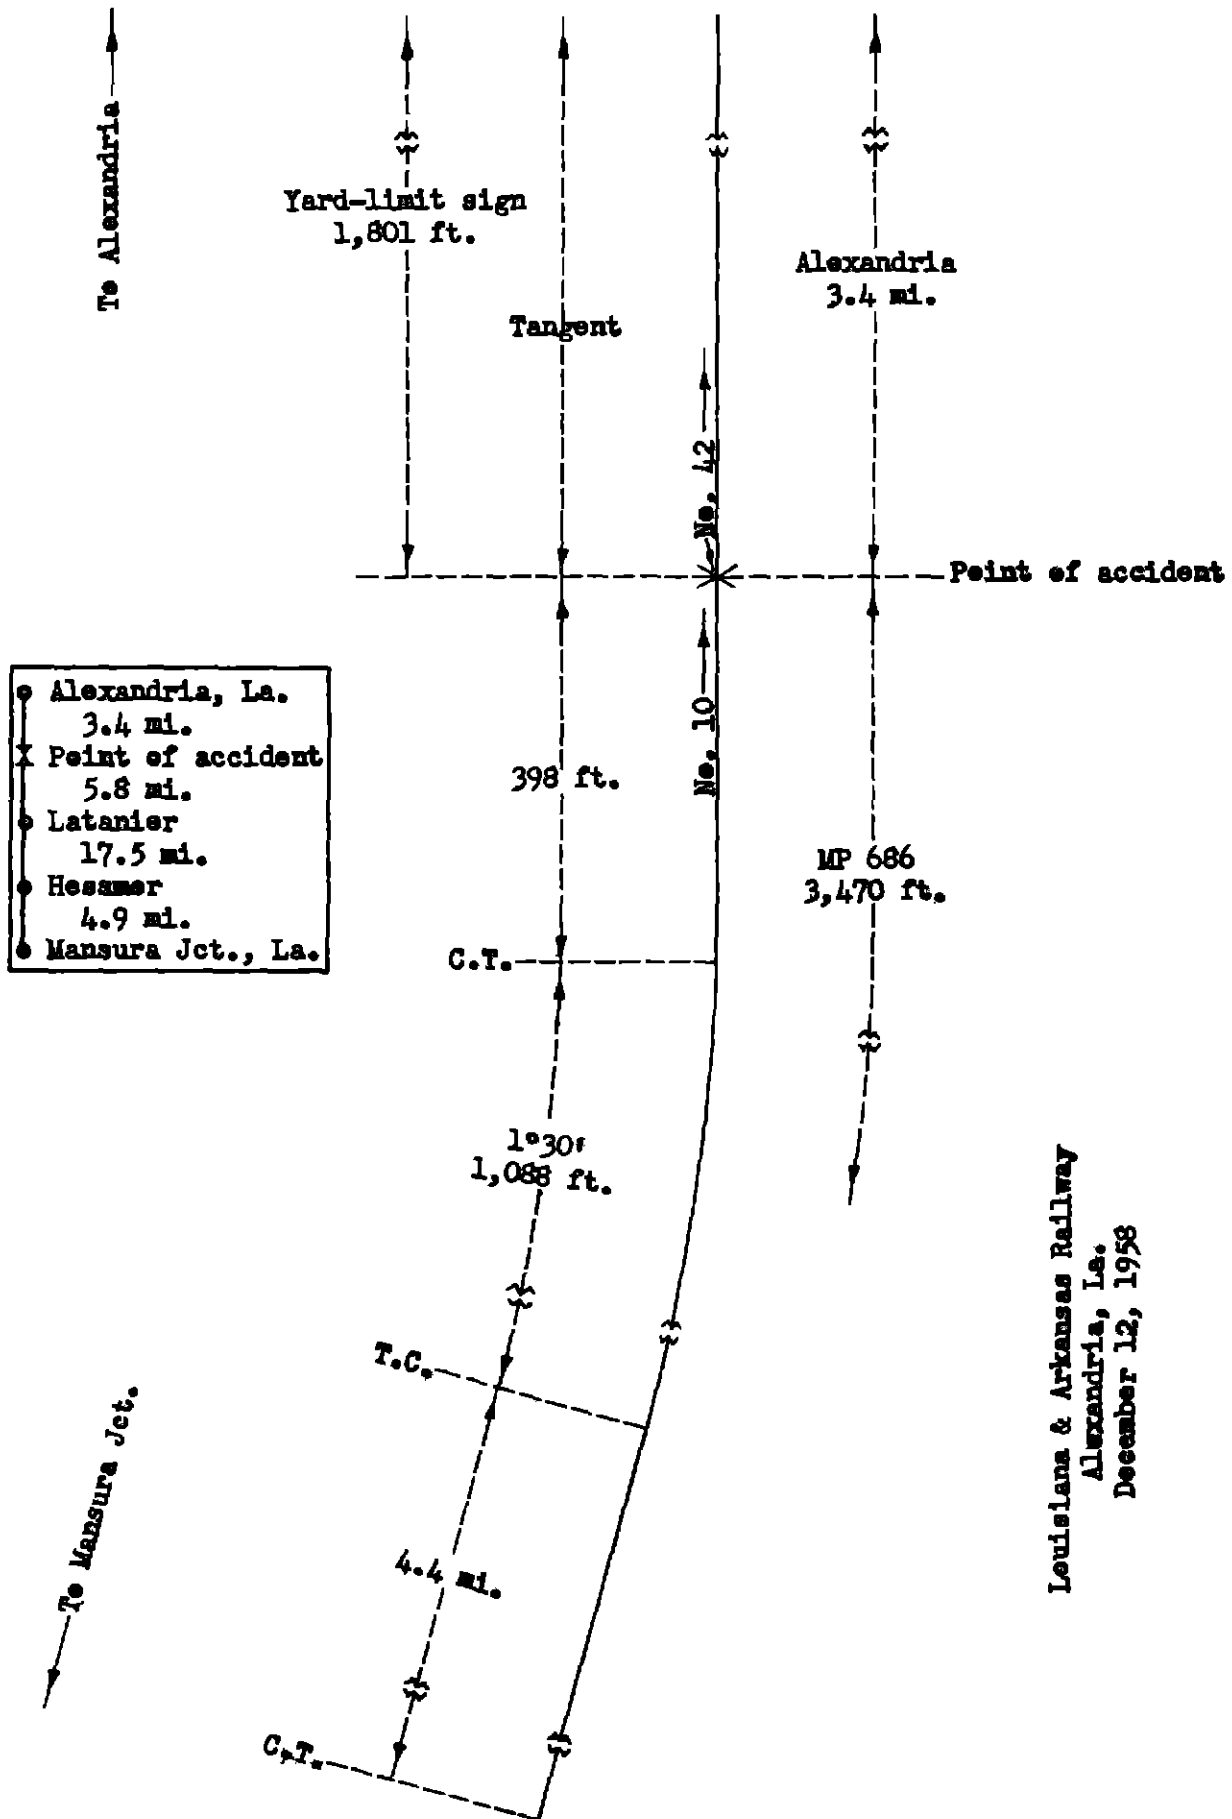
Louisiana & Arkansas Railway  
 Alexandria, La.  
 December 12, 1958

This accident occurred on that part of the Louisiana and Arkansas Division extending between Mansura Jct and Alexandria, La, 31.6 miles, a single-track line over which trains are operated by timetable and train orders. There is no block system in use. The accident occurred on the main track at a point 3.4 miles south of the station at Alexandria and 1,801 feet south of the Alexandria yard limits. From the south there are, in succession, a tangent 4.4 miles in length, a 1°30' curve to the left 1,088 feet, a tangent 398 feet to the point of accident and a considerable distance northward. From the south the average grade is 0.33 percent ascending 3,000 feet, 0.34 percent descending 1,300 feet, 0.48 percent ascending about 60 feet to the point of accident and 840 feet northward.

The caboose and the 150th car of No 42 were derailed and stopped on the track structure about in line with the track. The superstructure of the caboose was telescoped by the locomotive. The caboose was destroyed and the 150th car was heavily damaged. The locomotive of No 10 stopped with its front end on the rear end of the 150th car of the preceding train at a point about 100 feet north of the point of collision. A separation occurred between the locomotive and the first car. The locomotive and the first car were derailed and stopped in line with the track structure. The locomotive and the 3rd and 4th cars were heavily damaged. The 1st car was slightly damaged and the 2nd and 5th cars were considerably damaged.
